# Thermal analysis of façades through infrared thermography for the identification of variables associated with surface temperature differences in buildings located in warm climates

**Abstract:** The thermal behavior of architectural envelopes directly influences comfort conditions and energy consumption in buildings located in warm climates. Therefore, the objective of this paper is to analyze the thermal behavior of façades through infrared thermography for the identification of surface temperature differences and, in this way, evaluate the thermal impact of architectural design variables on thermal comfort in buildings located on the campus of the Francisco de Paula Santander University, in San José de Cúcuta, Colombia. The methodology is quantitative with an experimental approach based on in situ measurements using specialized technology for data collection. Three representative case studies were selected for the comparative analysis of variables such as orientation, materiality, and surroundings. The results indicate that southeast and southwest orientations present the highest surface temperatures, exceeding 40°C. Furthermore, materials such as grooved concrete and concrete

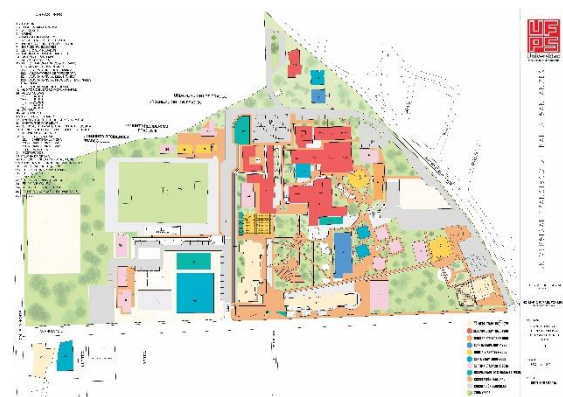
**Fig. 1.** Urban plan of public spaces with UFPS projections.  
 Source: UFPS Planning Office (2019).

For the identification and selection of the case studies, an initial survey of the buildings on the Universidad Francisco de Paula Santander campus, Cúcuta campus, was conducted based on planimetric information provided by the institutional planning office, complemented by in situ observations. Figure 1 illustrates the urban plan of the UFPS university campus. This stage made it possible to establish a database of 55 buildings and spaces located on the campus, including variables such as typology, use, volumetric configuration, and general characteristics of the buildings.

Based on this information, an initial classification was established according to the number of floors: buildings with 1 or 2 floors (E1), buildings with more than 3 floors (E2), open-plan structures with roofs (P), and open spaces (A). According to this classification, 50% of the properties correspond to

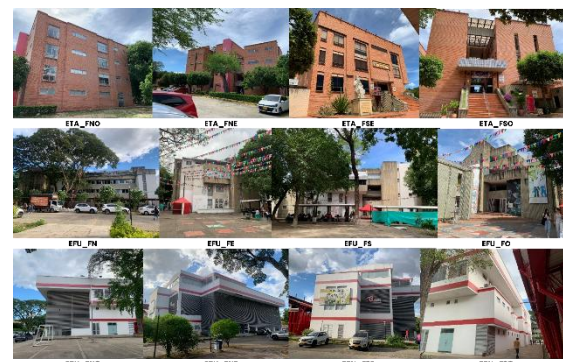
**Fig. 3.** Representative façades of the selected case studies after classifying the buildings according to the number of floors, main façade materials, and construction stage.

Under this observation framework, the Torre Administrativa building was identified as being characterized by the predominant use of exposed gres brick as an envelope system. The Fundadores building is characterized by the presence of traditional materials, such as concrete with smooth and fluted textured finishes. The Bienestar Universitario building stands out for its combination of reinforced concrete frame systems, smooth finishes, and metal envelopes, allowing variations in façade configuration and their relationship with the surrounding environment to be analyzed.

The façades were coded according to their orientation with respect to the cardinal directions: north (FN), northeast (FNE), northwest (FNO), east (FE), west (FO), south (FS), southeast (FSE), and southwest (FSO). This made it possible to standardize the identification of the analyzed surfaces. Figure 3 identifies the façades according to the site layout of the Torre Administrativa (ETA), Fundadores (EFU), and Bienestar Universitario (EBU) buildings on the UFPS campus.

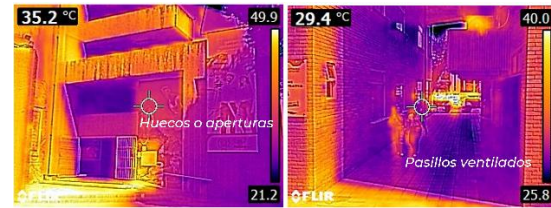
**Fig. 6.** Thermographic images of openings and naturally ventilated corridors in buildings.

The exposed-face brick records an average temperature of 35.2 °C, similar to that of the reinforced concrete frame structure. Thermal performance improves on the NE façade (32.9 °C), but increases on the SE façade (39.5 °C). Meanwhile, elements such as glass windows and aluminum framing record average temperatures of 31.6 °C and 33.7 °C, respectively, and are also present in all three case studies. In contrast, openings or apertures exhibit the lowest thermal values among the façade surface category, with an average temperature of 27.9 °C, as shown in Figure 6.
